12. PARTICIPATION IN THE FUSION TECHNOLOGY PROGRAMME

12.1. INTRODUCTION

The Portuguese participation in the Fusion Technology Programme during 2002 was concentrated on the following tasks:

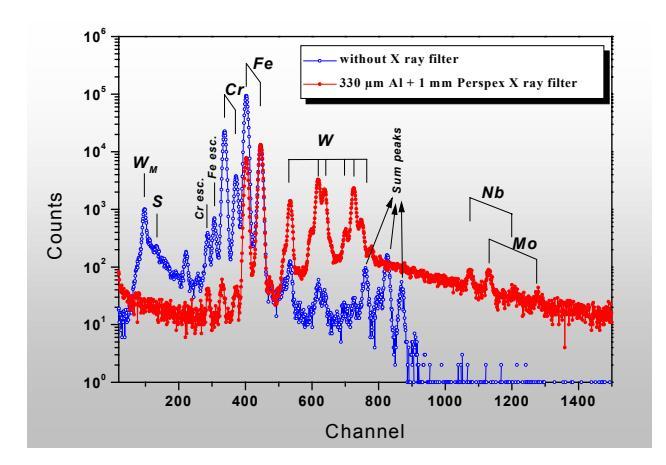
Figure 12.1 - Typical PIXE spectra obtained with and without X-ray filter.

Several Eurofer heats (E83694, E83698 and E83699) with different shapes were analysed with ion beam techniques (PIXE and RBS), Instrumental Neutron Activation Analysis (INAA) and Ion Cyclotron Resonance (ICR). Undesired elements in the Eurofer batches were detected in concentrations well above the radiological desired values even for some elements whose identification should be very difficult due to their expected very low contents. Figure 12.1 shows a typical PIXE spectrum revealing most of the elements presents in one of the analysed batches and reveals that Nb is well above the 10 ppb limit (>7 ppm) and the same happens for Co (limit 1 ppm but concentrations above 30 ppm were determined).

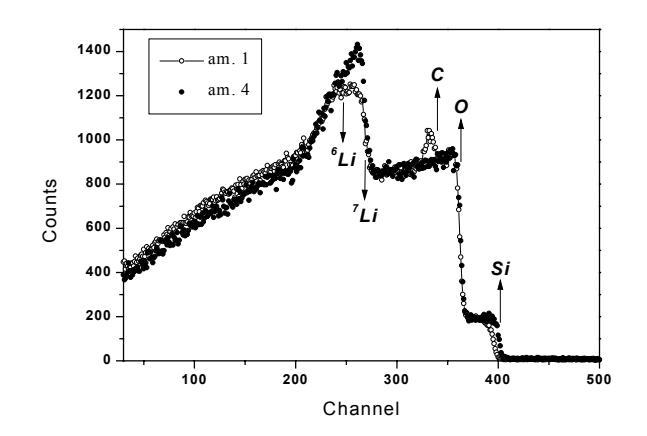
Figure 12.3 – Obtained RBS spectra from FZK Li orthosilicate pebbles: sample Am 1 (⁶Li enriched) and Am 4 (natural ⁶Li enrichment). The spectra main difference is due to the different amount of ⁶Li and ⁷Li in the samples.

The nominal 20% enrichment on ${}^{6}Li$ in sample referenced as 00/2-3 (Am 1 in this work) was measured to be achieved (Figure 12.3).

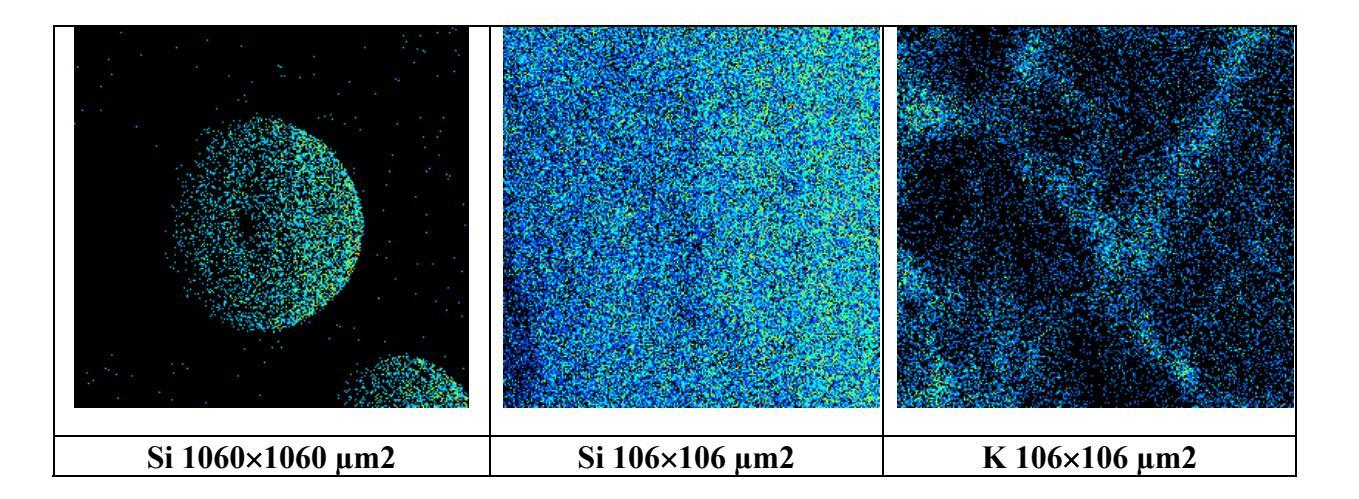
Figure 12.2 – Si and K x-ray elemental maps obtained from sample Am 2 for two different scanning sizes. Lighter colours represent higher concentrations.

For the orthosilicate pebbles produced at FZK, the ones referenced as 01/3-3 (Am 4 in this work) reveal that the C compound layer that was found at the surface of all the other type analysed samples was successfully removed. Sample referenced as 01/2 (Am 2 in this work) was the only one to present elemental surface distribution inhomogeneities of K, that at the same time presents high concentrations of this element that is barely found in any of the other FZK analysed samples (Figure 12.2).

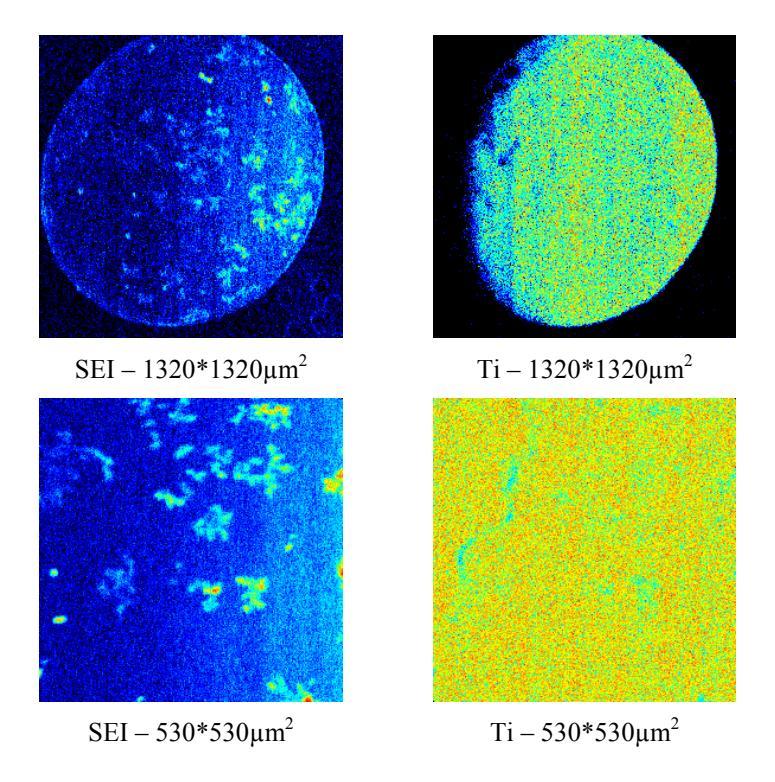
Fig. 12.4 – Secondary electron image (SEI) and Ti map from a Li pebble annealed for 30 days

change in composition except some tendency of the Si content to increase in the zones were the SEI (secondary electron image) signal is more intense. This SEI contrast appears as a dendritic type formation (Figure 12.4), whose spatial extension increases with annealing time, endeavouring the formation of different material phases.

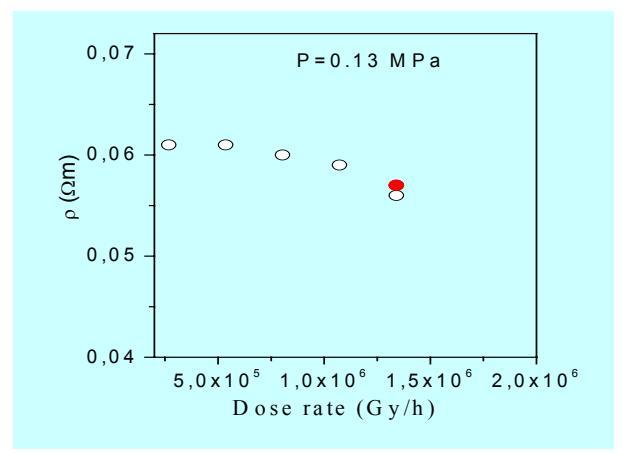
Figure 12.5 – Resistivity of a Be pebble bed filled under an atmosphere of $He+ 0.1\%H_2$ and compressed to 0.13 MPa as a function of gamma dose rate.

Although it is impossible to reproduce the envisaged conditions of the fusion power reactor, experimental results on the electrical conductivity of Be pebble bed suggest that it is the purging gas present the main responsible for the conductivity in the presence of ionizing radiation. The resistivity reveals a nearly linear decrease with a very small slope with the increase of the γ dose rate (Figure 12.5). This allows us to extrapolate a value of at a typical γ dose rate

of a fusion power reactor, which is still several orders of magnitude higher than the resistivity value of RAFM steel, used as structural material, eliminating any possibility of significant electromagnetic loads in the beryllium pebble beds. According to this study the extrapolated resistivity of the Be pebble bed to real operating conditions, is high enough to prevent any meaningful current flowing in the Be pebbles in case of plasma disruptions even under irradiation conditions.

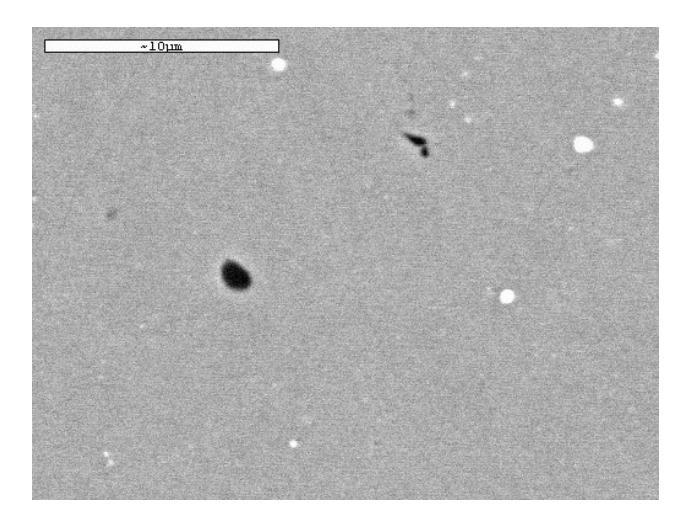
Figure 12.6 - Backscattered electrons image of Fe-Mn sulphides (black) and Ta-rich inclusions (bright spheres), left and of Si-Ti rich inclusions, right.

Metallographic studies show the presence of non-metallic inclusions and small pores in all the Eurofer samples. The most numerous are seen in grey colour and where identified as Fe-Mn sulphides by electron microscopy (Figure 12.6).

The presence of Ti-rich inclusions were also found which is surprising as the chemical analysis reveals Ti levels below detection limits in all the specimens. Also Ta and Si-rich inclusions where seen during the observation in the scanning electron microscope. Those are seen as white spheres in the backscattered electron image and where detected in all the specimens.

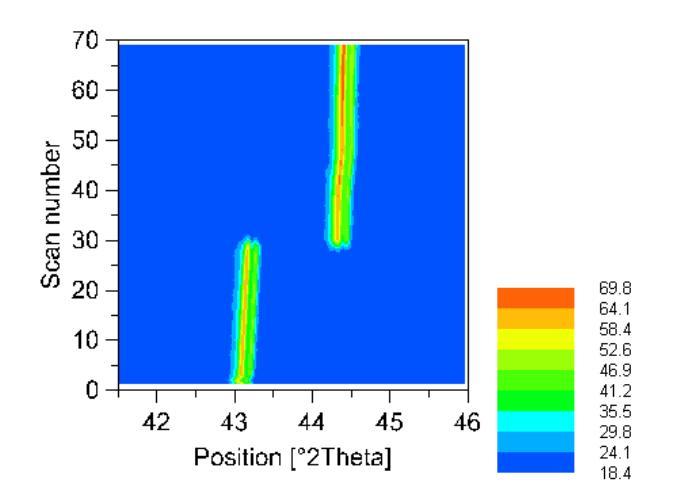
Figure 12.7 - 2D spectrum plot of the intensity of the austenite (left) and (right) ferrite peaks during the cooling experiments.

The structure is fully lath martensite with small prior austenite grain size. No δ -ferrite was detected in any of the samples by light microscopy. Carbides are dispersed homogeneously throughout the martensitic structure. The high temperature XRD experiments show that the austenite starts to form at 755 °C and that at 780 °C the structure is fully austenitic as seen by this technique (Figure 12.7).
